Home Inspection Report Provided For
Bob Smith
1234 Main St
Somewhere, TX 76148

PROPERTY INSPECTION REPORT

Concerning: 1234 Main St, Somewhere, TX 76148
(Address or Other Identification of Inspected Property)

By: Nick Morrow, Lic #20459 05/10/2016
(Name and License Number of Inspector) (Date)

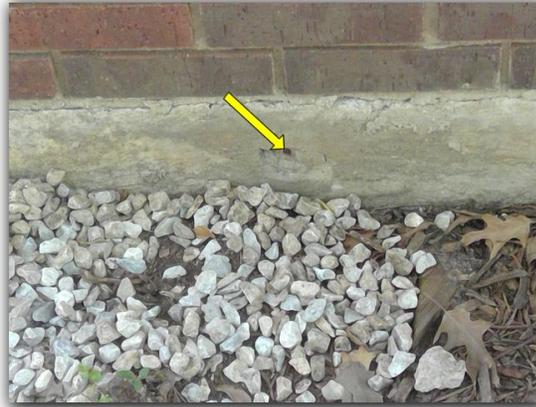
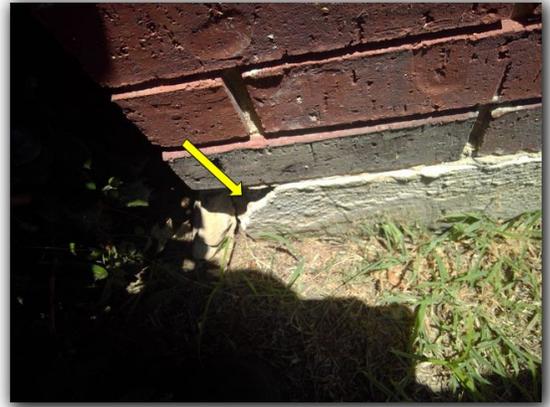
1. There is evidence that instability/movement has occurred. Given the age and location this is not uncommon. Due to the inherent nature of the expansive clay soil in the area some deflection is normal and should be expected. We did however observe conditions (brick cracking, Wall cracks, garage door/brick separation) that warrant additional assessments and a more complete analysis should be undertaken by a qualified foundation specialist or a structural engineer. The rate of movement cannot be determined on a one time visual inspection.

2. Exposed cable endings were observed. Over time the seals covering these cable ends has deteriorated and exposed the end sections. Resealing as needed is recommended. We are required to cite this condition per the Texas Real Estate Commission.

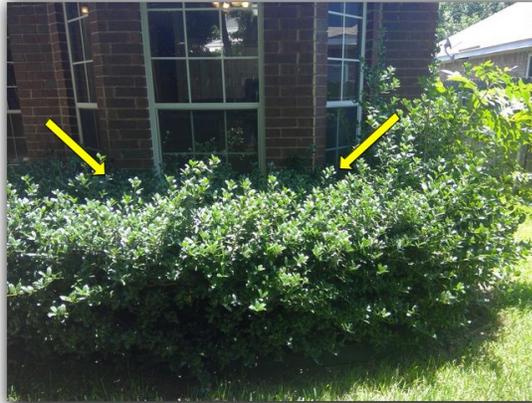
4. The heavy foliage should be trimmed to allow visual observation for potential WDI (termite infestation).

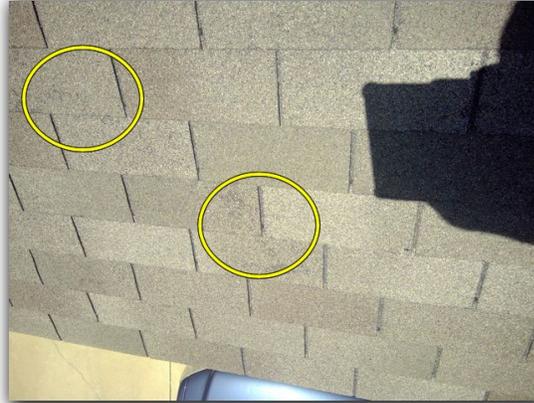
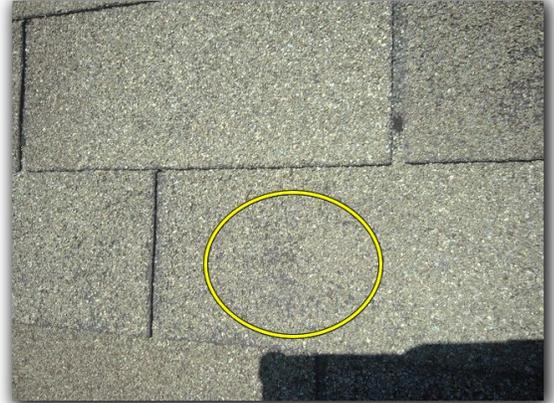
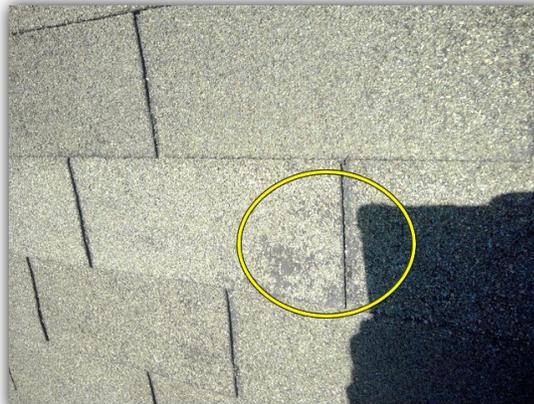
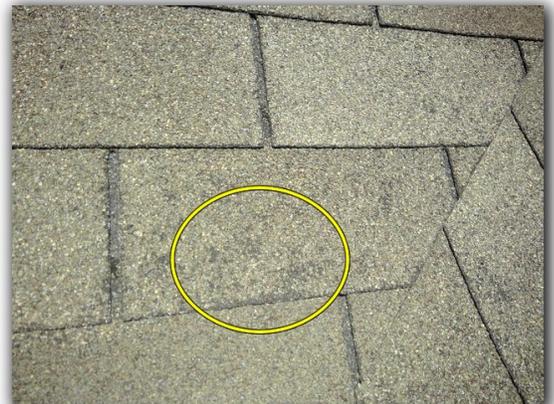
5. Evidence of hail damage is present. We recommend that our client consult a qualified roofer prior to closing on this home to determine what repairs will be required.

6. We observed damage to the roof covering materials at various exposure(s). We recommend that our client consult a qualified roofer prior to closing on this home to determine what repairs will be required.

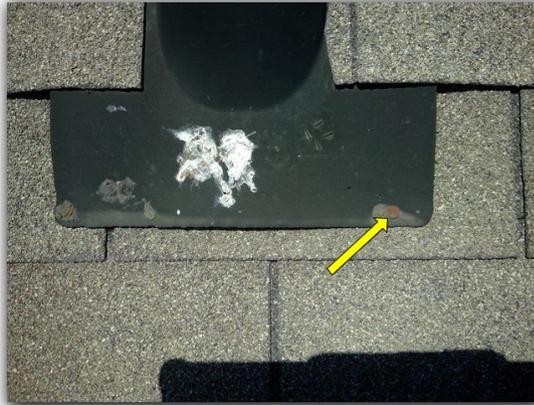
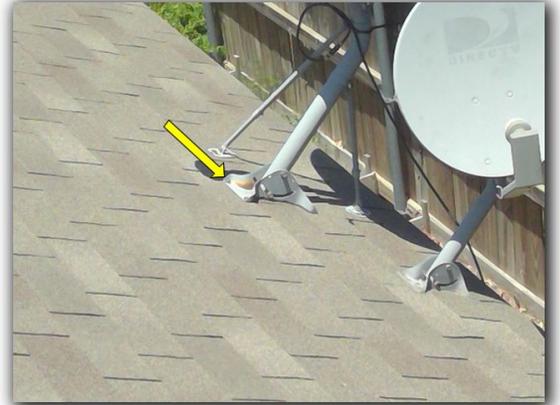
7. We observed exposed nail heads at the roof ridge and around the vent/ flashings. Recommend recaulk/reseal as necessary.

8. We observed the bolts on the satellite/antenna to be unsealed. This has the potential to allow water penetration to the structure and we recommend repair/replacement as necessary by an appropriate professional.

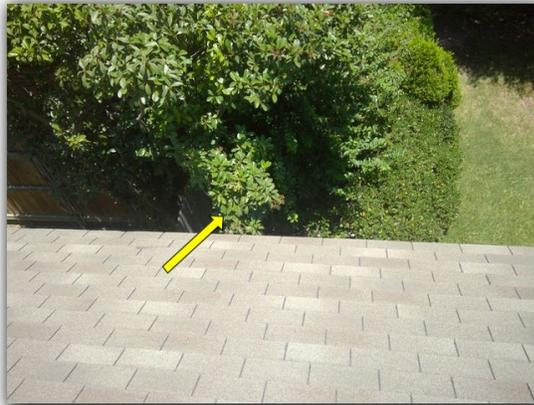
9. All tree limbs/branches should be cut back at least three feet from the roof cover.

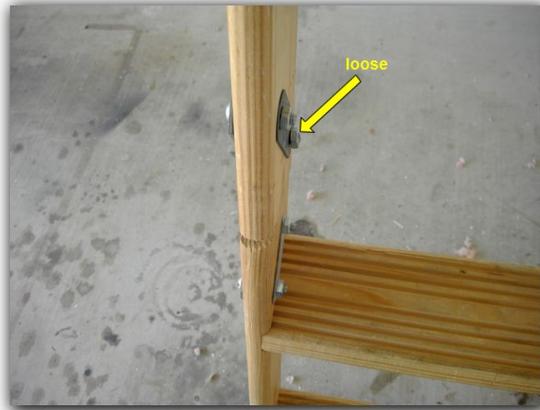
10. The attic access stairs were observed to have loose/missing hardware. This is a safety concern and we recommend repair by an appropriate professional.

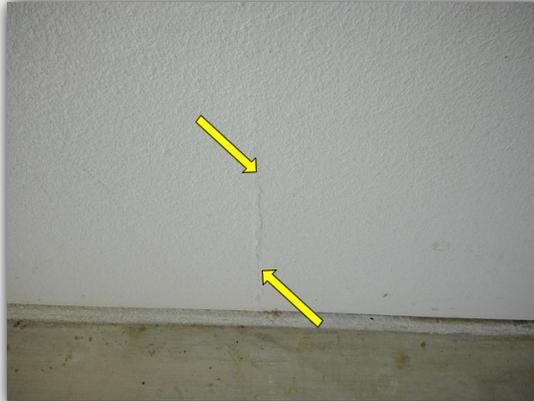
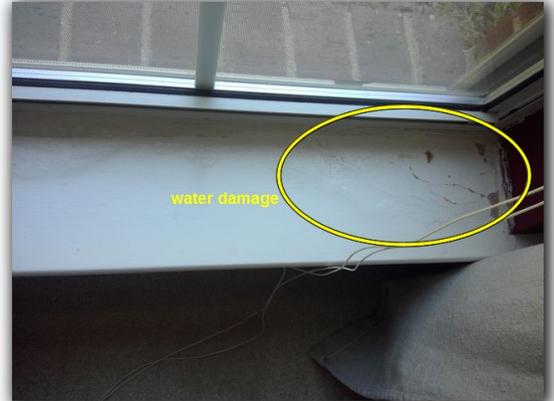
13. We observed the interior finish to be cracking in the garage. This implies some structural movement has occurred (see foundations section).

14. We observed water damaged conditions at the master bedroom window areas. We were unable to determine the source of the condition and suggest consulting the current owner/occupants for any specifics.

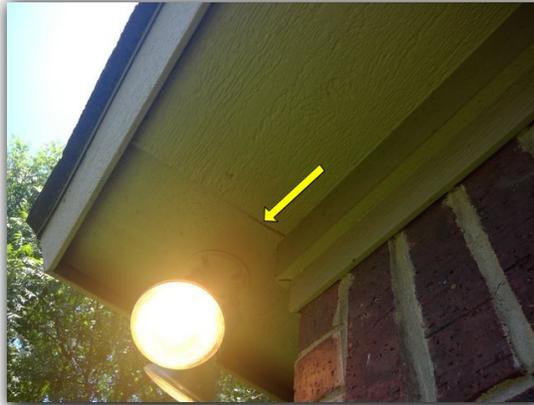
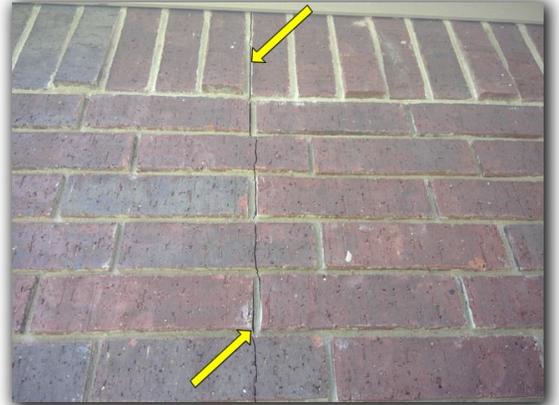
15. We observed the windows, mortar material, soffit material to have blistered/peeling paint, loose joints, need for repaint/reseal for improved durability. Recommend repair/replacement as necessary by an appropriate professional.

16. Cracks and or crack repair were observed at the north, south exposures. The condition suggest some instability has occurred. (See foundation section) The cracks should be re-pointed as needed.

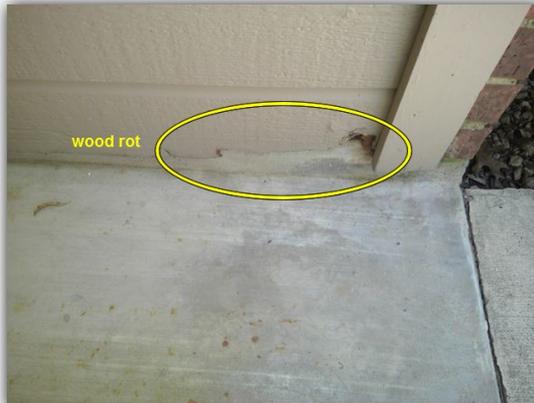
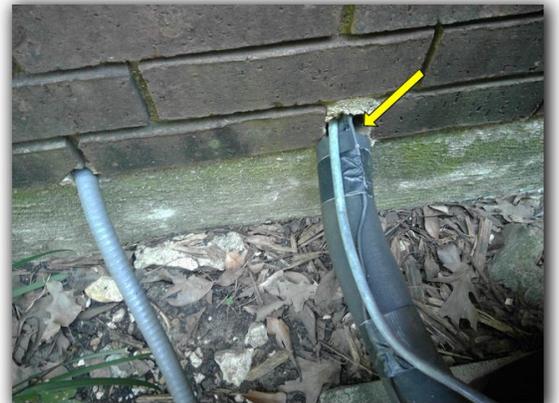
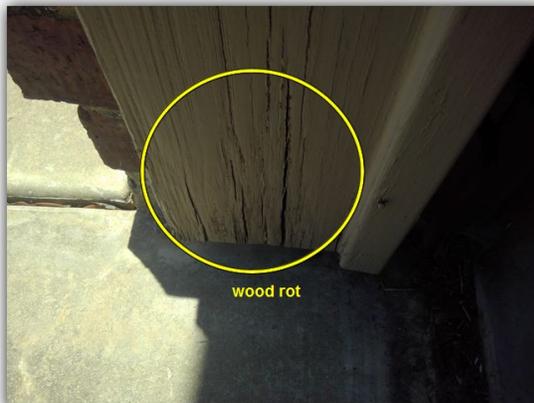
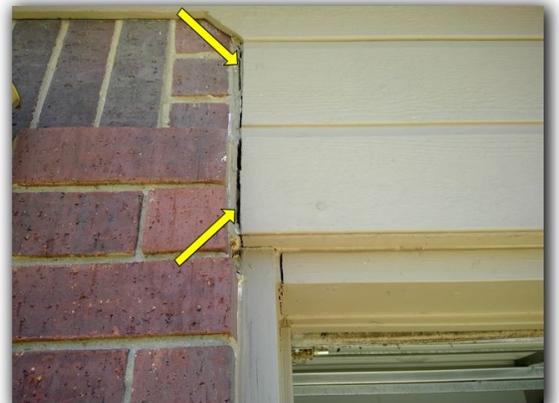
17. We observed the exterior trim, exterior siding, garage door frame to have wood rot, damage, need for repaint/reseal for improved durability. Recommend

repair/replacement as necessary by an appropriate professional.

18. We observed separation between the brick and garage door frame. This suggest some instability has been experienced(see foundations section). Resealing as needed is recommended.

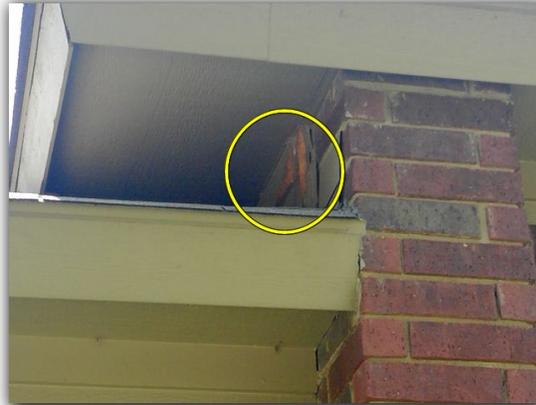
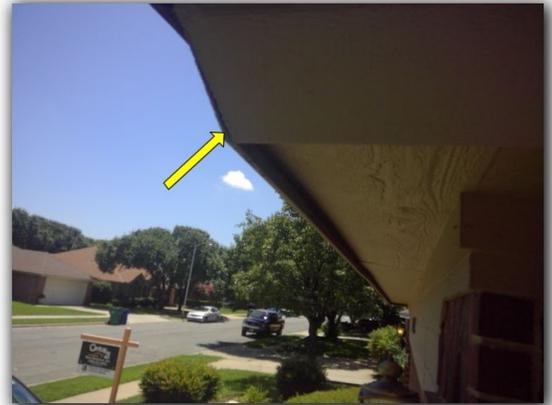
19. We observed vermin damage (likely squirrels) to the exterior trim at the east exterior. Recommend replacement/repainting as necessary.

20. We observed separation between the brick and frieze boards. This suggest some instability has been experienced. Resealing as needed is recommended.

21. We observed the siding in contact with the roofing material at the chimney. This condition may also conceal any step flashing that may be present. Generally a two inch separation is found between the differing materials. No signs of damage from the condition were noted at the time of our inspection. This condition is a common condition in older structures. Should modifications be desired a appropriate professional should be consulted.

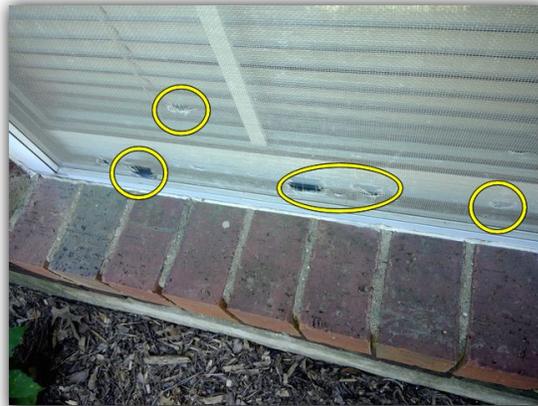
24. It may be desirable to replace damaged window screens where needed. The owner should be consulted regarding any screens that may be in storage.

25. Window(s) have lost their seals. this has resulted in foggy conditions and/or condensation developing between the panes of glass. Improvements should be undertaken as needed. (see red dots) This comment pertains to the following widows:

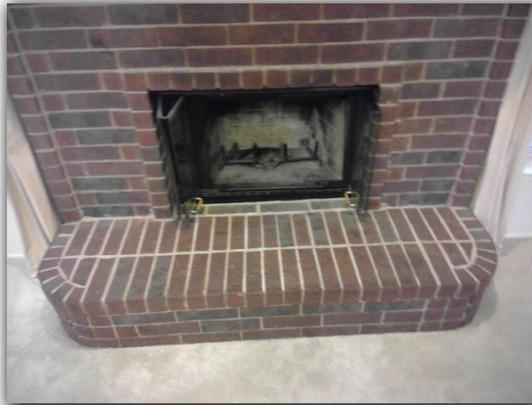
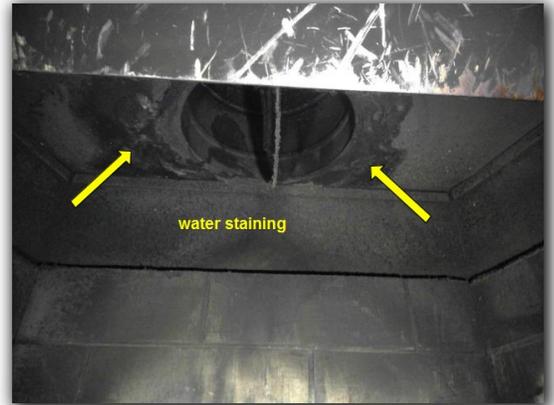
26. We observed water staining around the chimney flue. Recommend further evaluation/repair as necessary by an appropriate professional.

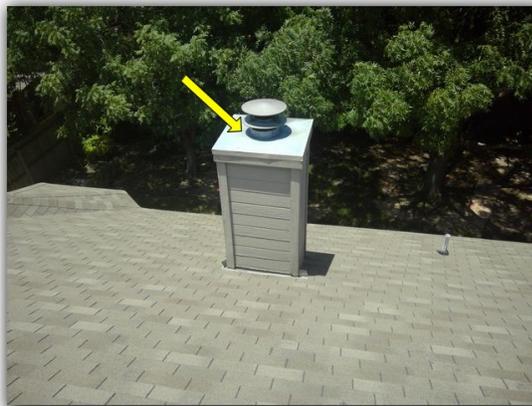
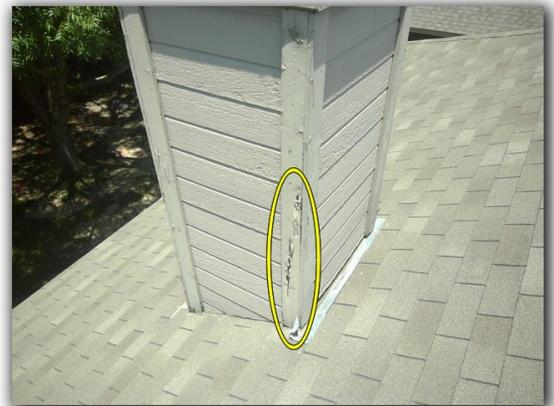
27. We observed evidence of previous standing water to the chimney cap. Recommend repair/replacement as necessary to allow drain-off by an appropriate professional.

28. We observed wood rot, damage, need for repaint/reseal for improved durability to the trim on the exterior of the chimney. Recommend repair/replacement as necessary by an appropriate professional.

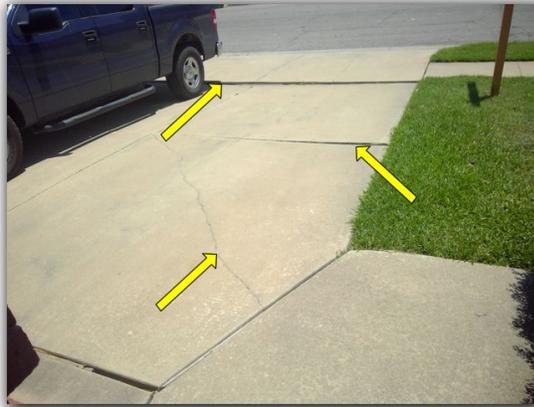
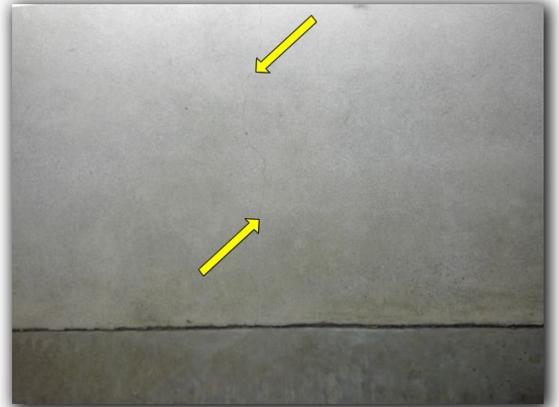
29. The driveway was observed to be cracking and settling. These cracks should be resealed as needed and should deck improvements be desired a concrete specialist should be consulted.

30. The rear patio was observed to be cracking. The cracks should be resealed as needed.

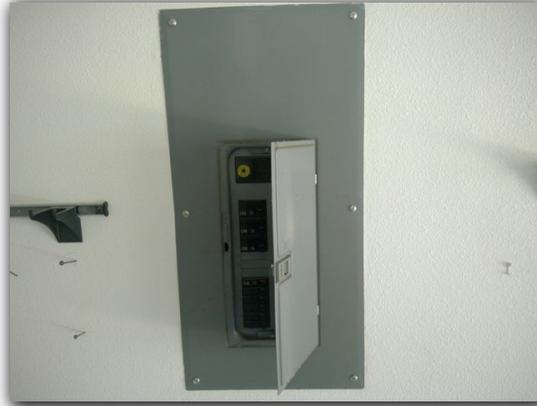
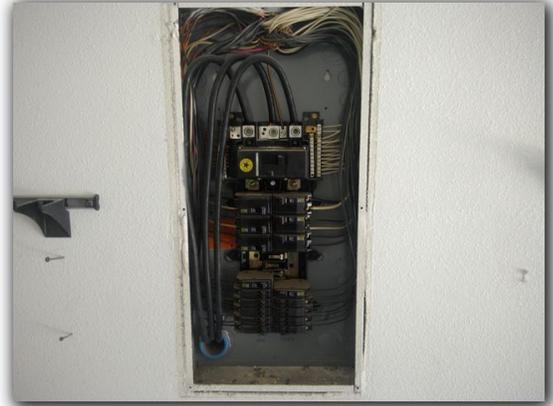
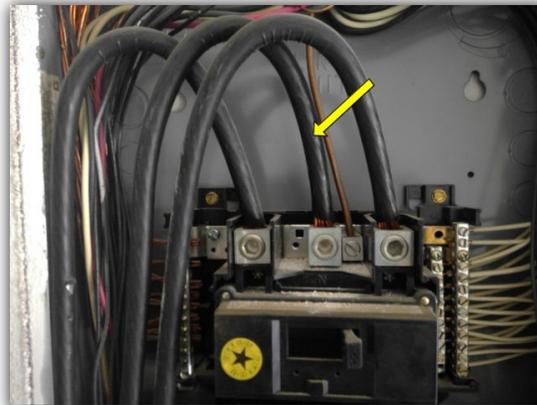
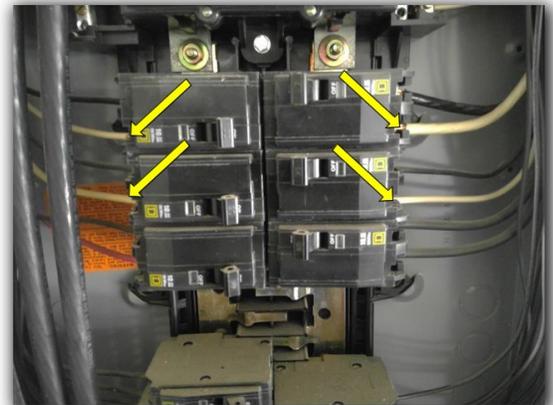
- 31. The main service ground wire inside the panel box should be wrapped with white or gray tape to indicate its function.
- 32. The white wiring connected to the 220 Volt breakers in the panel box should be color coded or wrapped in black tape to indicate that the wiring is hot.

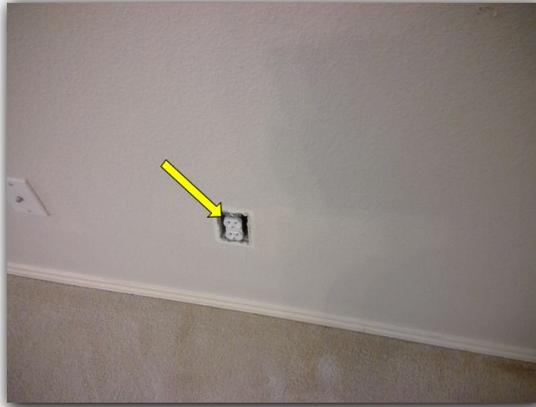
34. We observed missing outlet cover plate(s) in the rear family room. Recommend replacement as necessary.

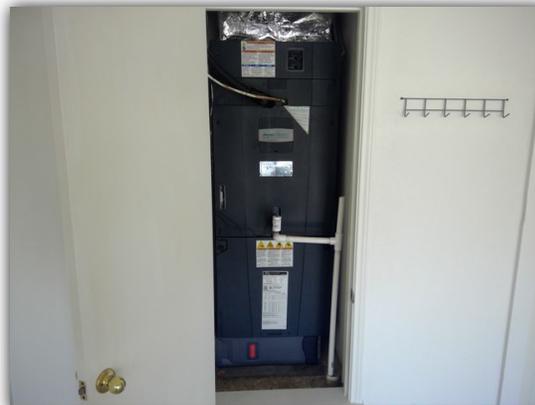
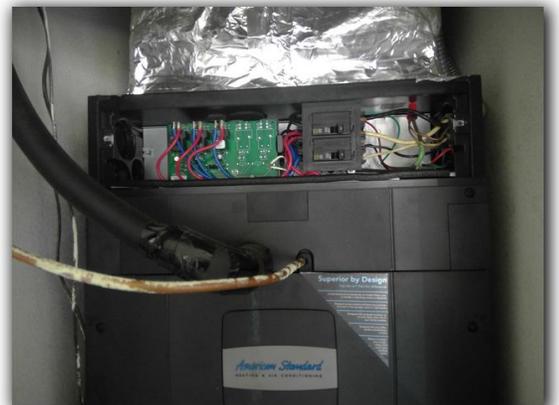
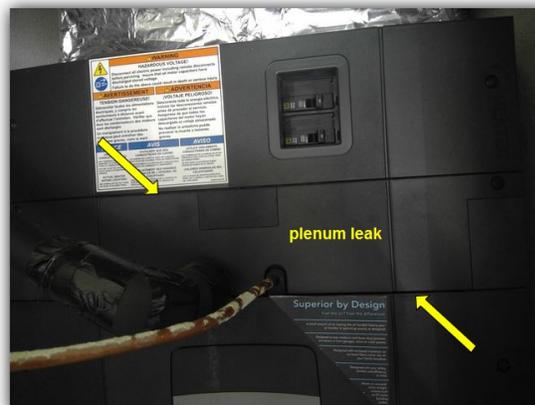
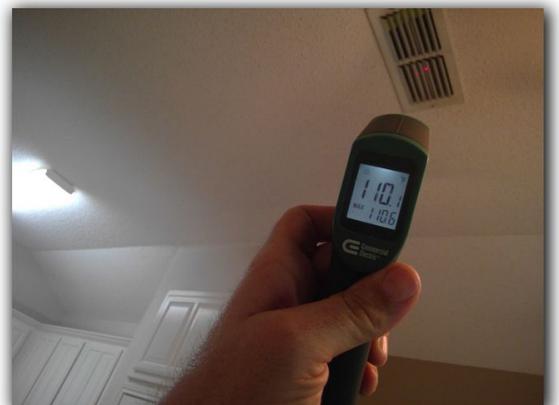
38. Air is escaping directly into the attic from a leak in the plenum. Recommend further evaluation/repair by an appropriate professional.

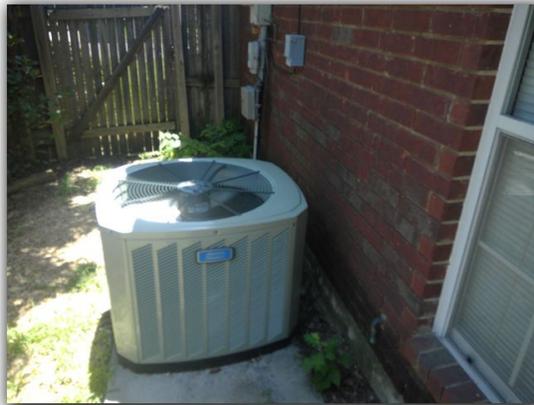
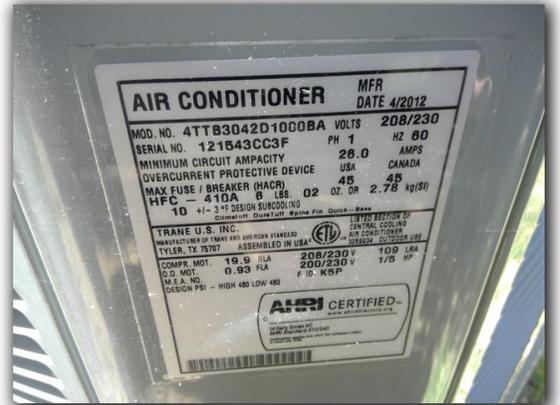
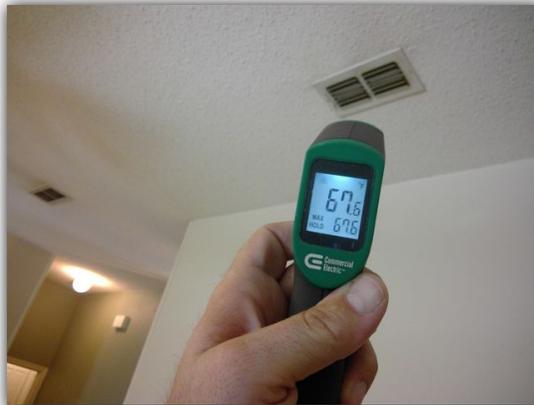
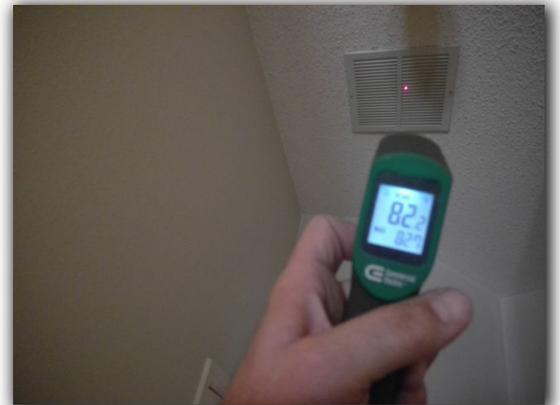
39. The temperature drop measured across the evaporator coil of the air conditioning system is lower than considered typical (12 to 15 degrees). This usually indicates that a servicing is needed. A qualified HVAC technician should be consulted to further evaluate this condition and the remedies available for correction.

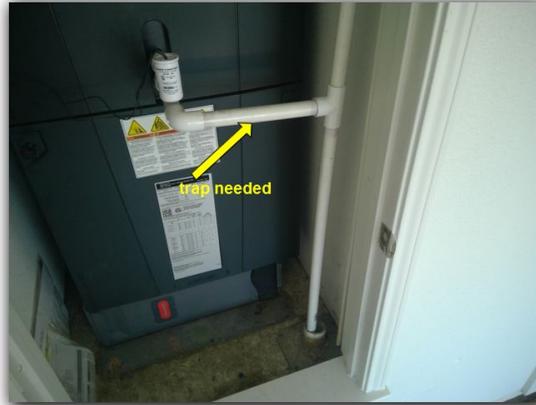
40. It appears that the primary condensation drainpipe improperly terminates into a sewer vent. This condition although not proper by today's installation practices is somewhat typical of older homes. The line should at the very least have an in-line trap between the unit and the drain connection as condensate drain lines for air conditioning systems that flow into sanitary drains should be "trapped" to avoid the potential for contamination. Should modifications be desired a qualified HVAC technician should be consulted.

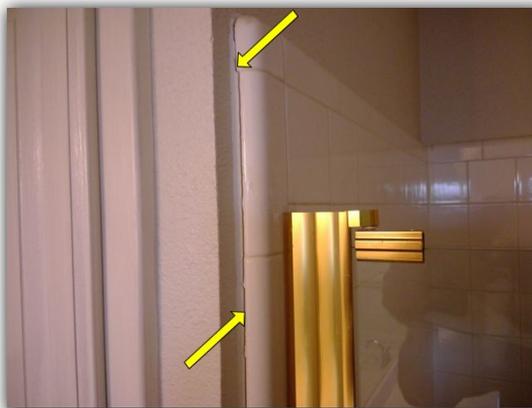
42. Water from the hot supplies was observed to be cooler than typically desired. 43. Recommend further evaluation/repair as necessary by an appropriate professional.

44. Cracked, deteriorated and/or missing master bathroom shower grout and caulk should be replaced.

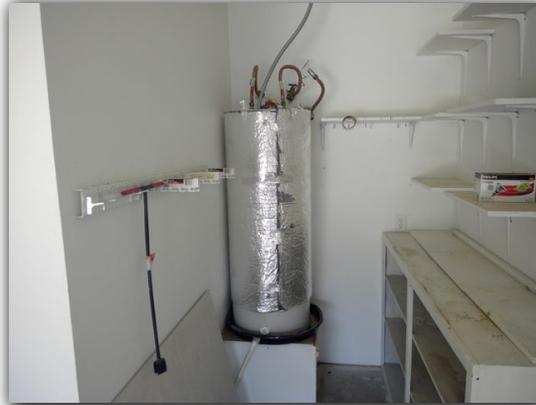
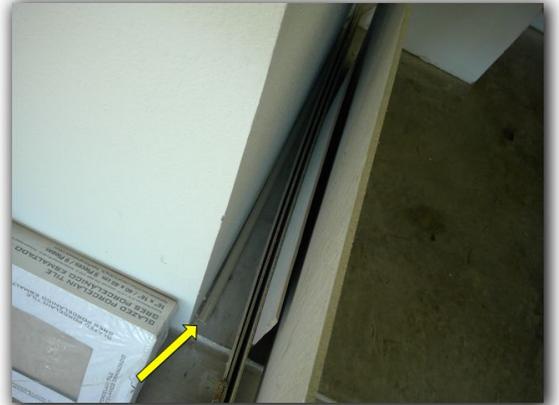
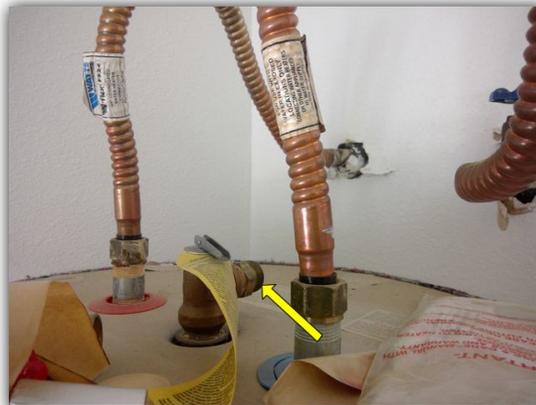
46. We observed the water heater drip pan drain line to be discharging to the garage floor. This discharge piping should terminate not less than 6 inches or more than 24 inches above the exterior ground and point downward.

47. The discharge piping serving the Temperature and Pressure Relief (TPR) Valve for the water heater was observed to be disconnected on both units. Recommend repair/replacement by an appropriate professional.

48. The water heater is an older unit that may be approaching the end of its useful life. It would be wise to budget for a new unit. One cannot predict with certainty when replacement will become necessary.

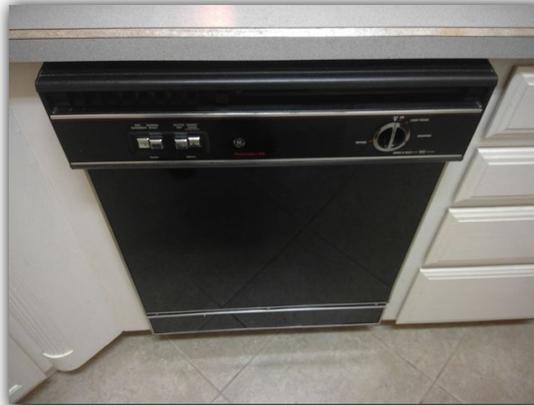
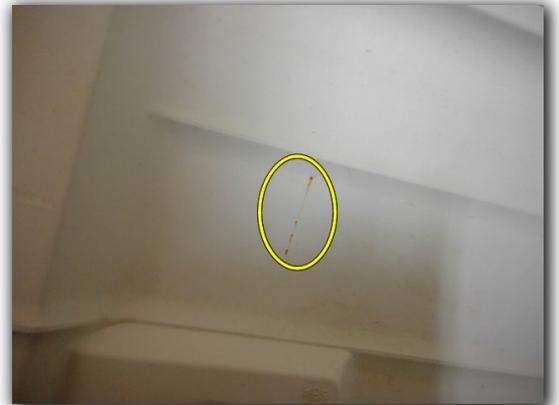
49. We observed rust staining on the interior of the unit. We are required to cite the condition per the Texas Real Estate Commission as deficient.

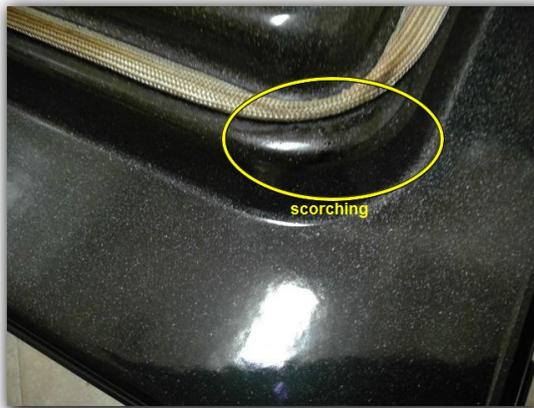
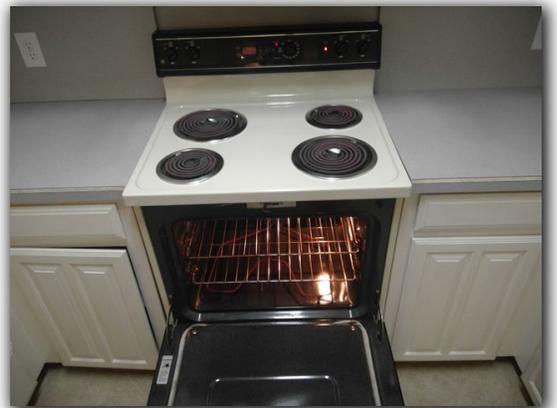
50. The range is missing the anti-tip device. This device helps insure the stability of the unit when the oven door is open.

51. We observed evidence of scorching to the oven door connection and gasket. Recommend repair/replacement as necessary by an appropriate professional.

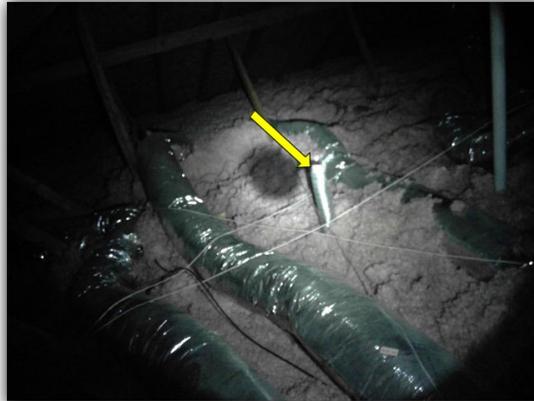
52. We observed the bathroom/utility room vents to discharge into the attic. All exhaust fans need to discharge to the building exterior and not directly into the attic. *Please note that this is a Texas Real Estate Commission mandated comment.*

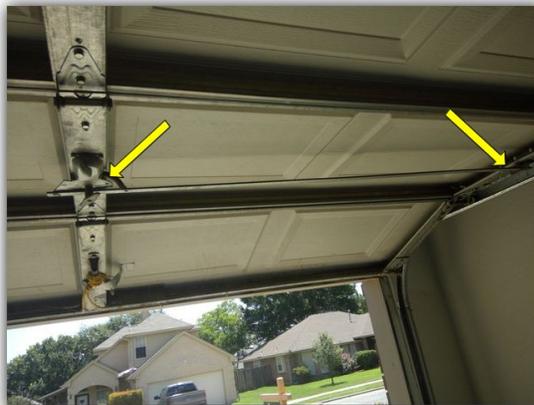
54. The locking mechanism on the garage door has not been disabled and/or removed. The Texas Real Estate Commission requires home inspectors to site this situation as a

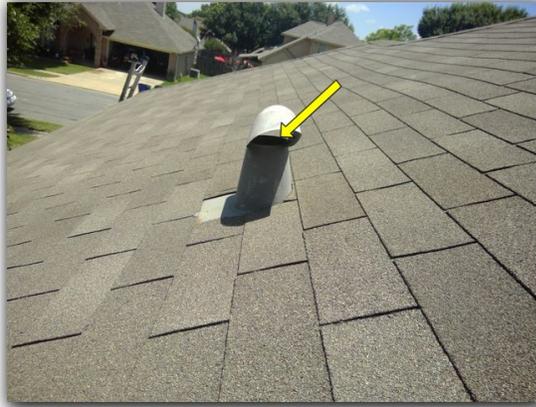
55. The clothes dryer exhaust vent pipe was observed to be missing a damper at the exterior termination point. Recommend repair/replacement as necessary.
